# Blue Origin Explosion - Preliminary Working Hypothesis

## Summary

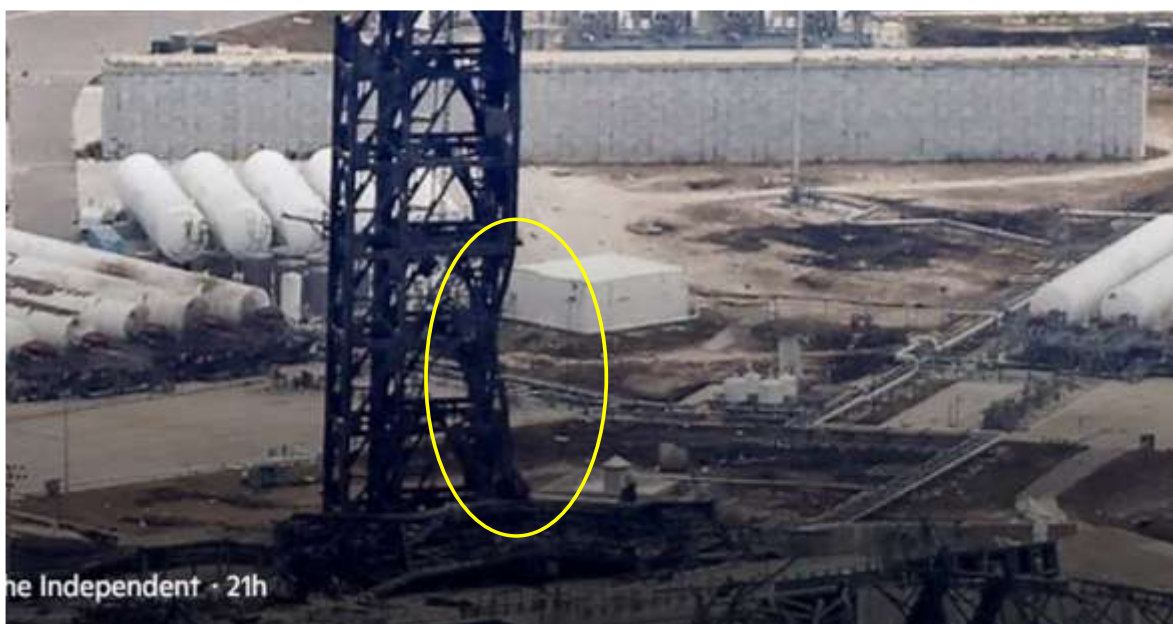
**Figure 4. Author's annotated photo post blast published by "The Independent"**

A second post-blast image adds another important clue. It appears to show low-level deformation or impact damage at the base of the main tower structure. The damage is concentrated low on the structure rather than high on the tower or vehicle. This low damage location is spatially consistent with a pressure source in the launch-mount, engine-bay, flame-trench, or flame-duct region. It is less consistent with a primary high-level tank or upper-vehicle event as the initiating explosion site.

The apparent deformation of the lower tower structure suggests that the local blast loading was not merely a benign venting or flash-fire event. As a screening estimate, visible steel-frame distortion and local structural disruption are consistent with incident overpressures of at least a few psi, with a more plausible major-damage range of approximately 5–10 psi at the affected structure. Because the suspected source region is close to structural surfaces and may have involved a covered flame duct, local reflected or duct-channelled pressures could have been significantly higher than the free-field incident pressure.

This hypothesis is credible because it accounts for several observations with one coherent mechanism. The visible white vapour suggests the possible presence of cold cryogenic gas or propellant outside the intended internal engine flow path. Its low, base-side location points toward the vehicle/pad interface, purge/vent route, engine bay, flame trench, or duct geometry rather than a purely internal late-stage chamber failure. The apparent disruption of the covered trench or duct structure is consistent with pressure generation in or near a semi-confined channel. The low-level damage on the main tower structure is also consistent with a blast source near the base rather than higher on the vehicle.
